ASBESTOS IN ATTIC INSULATION

AFFIDAVIT OF RICHARD HATFIELD
IN SUPPORT OF PLAINTIFFS'
APPLICATION FOR PRELIMINARY
INJUNCTION AND EMERGENCY
NOTICE TO CLASS MEMBERS

1 10. I am familiar with testing performed in July 1993 by MAS in which MAS found
2 asbestos in bags of Grace's Zonolite Attic Insulation. In its report dated July 26, 1993, MAS
3 concluded that tremolite-actinolite was found to be associated with the vermiculite and as free
4 respirable fibers in the fine dust. I am appending the report as Attachment B.

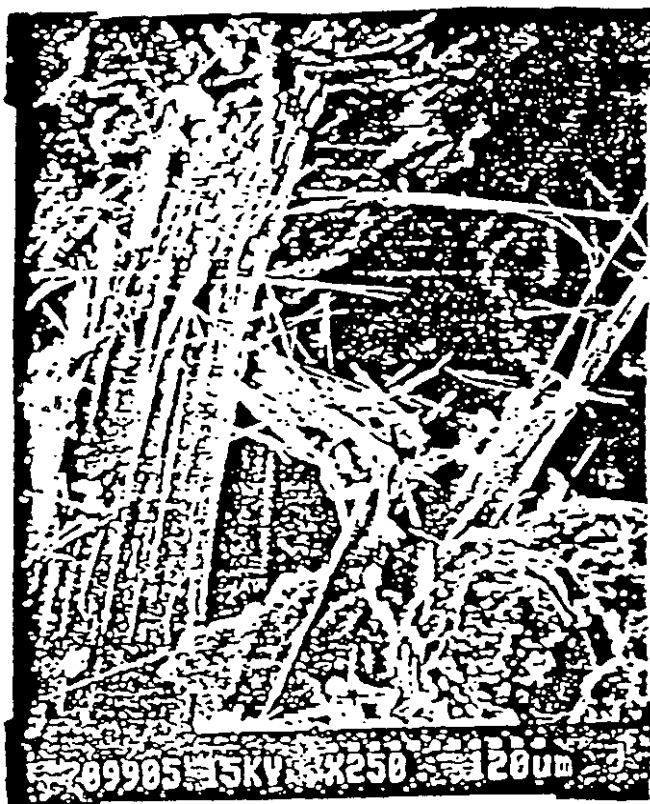
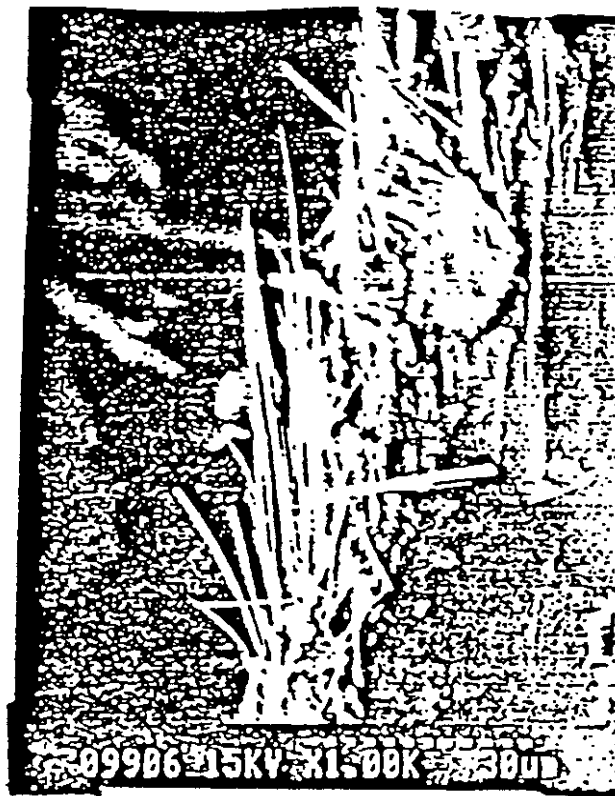
FIGURE 5

Our analysis showed that there was tremolite-actinolite found in with the vermiculite in the Zonolite Attic Insulation product (figures 5 through 11). The tremolite-actinolite was found both associated with vermiculite and as free respirable fibers in the fine dust as shown in figures 14 through 16.

It is therefore our conclusion that the tremolite-actinolite does remain associated with the vermiculite after the ore is fully processed and can be found with the finished product, as demonstrated with the W.R. Grace Zonolite Attic Insulation.
